DAVID W. G. RIDLEY
Senior Coroner for Wiltshire and Swindon

<p>REGULATION 28 REPORT TO PREVENT FUTURE DEATHS</p> <p>THIS REPORT IS BEING SENT TO:</p> <p>██████████ Senior Traffic Management Engineer Wiltshire Council – Highways County Hall Trowbridge Wiltshire BA14 8JN</p>
1	<p>CORONER</p> <p>I am DAVID W. G. RIDLEY, Senior Coroner for Wiltshire and Swindon</p>
2	<p>CORONER'S LEGAL POWERS</p> <p>I make this report under paragraph 7, Schedule 5, of the Coroners and Justice Act 2009 and regulations 28 and 29 of the Coroners (Investigations) Regulations 2013. http://www.legislation.gov.uk/ukpga/2009/25/schedule/5/paragraph/7 http://www.legislation.gov.uk/ukxi/2013/1629/part/7/made</p>
3	<p>INVESTIGATION and INQUEST</p> <p>On 14/03/2014 I commenced an investigation into the death of Tracy Michelle ROOKE aged 43. The investigation concluded at the end of the Inquest on 06 October 2014. The conclusion of the Inquest was that Tracy sustained multiple traumatic injuries as a result of a road traffic collision that occurred on 13 March 2014 on the A3102 at Mile Elm, Wiltshire.</p>

Discussion and recommendations

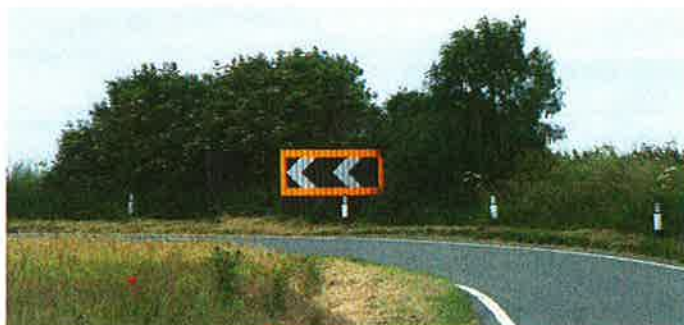
Road signs – there is a lack of consistency in that a 'slippery road' warning is only given to drivers travelling south. The double bend sign (photograph 2) is in a poor condition and the position of the sign pole is such that the signs are obscured by a telegraph pole. Verge marker posts and chevron markers are ineffective due to damage / vegetation or dirt.

Road markings – these are in a worn condition. The double white line system for southbound traffic does not commence until the apex of the bend (photograph 2) allowing drivers the opportunity to overtake without an appropriate view ahead. The 'catseyes' within the white line system are in a poor condition and ineffective.

Recommendation: A 'slippery road' warning sign should be provided to warn drivers travelling north. The double bend sign for southbound traffic should be replaced, with consideration for the sign pole being relocated to avoid it being obscured by the telegraph pole. Verge marker posts / chevrons should be cleaned, damaged posts replaced and vegetation cut back and maintained – an alternative could be to replace the verge markers and chevrons with more modern flexible chevron posts on both approaches to the bends (example below). This could reduce the level of signage / maintenance required whilst highlighting the presence of the bends.

Recommendation: the road markings should be repainted, the solid white line system for southbound traffic extended to approximately 100 metres prior to the bend (this would be similar to the northbound approach). The 'catseyes' should be refurbished and maintained.
