**Coroners (Investigations) Regulations 2013 – Regulation 28
Mr Warren Michael Myers, Deceased**

Site Investigation Following Fatal Accident Report

**DURHAM COUNTY COUNCIL (REGENERATION & ECONOMIC DEVELOPMENT)
STRATEGIC TRAFFIC MANAGEMENT
SITE INVESTIGATION FOLLOWING FATAL ROAD ACCIDENT REPORT
M/T/S16/16
(relates to accident record no. M/T/R16/16)**

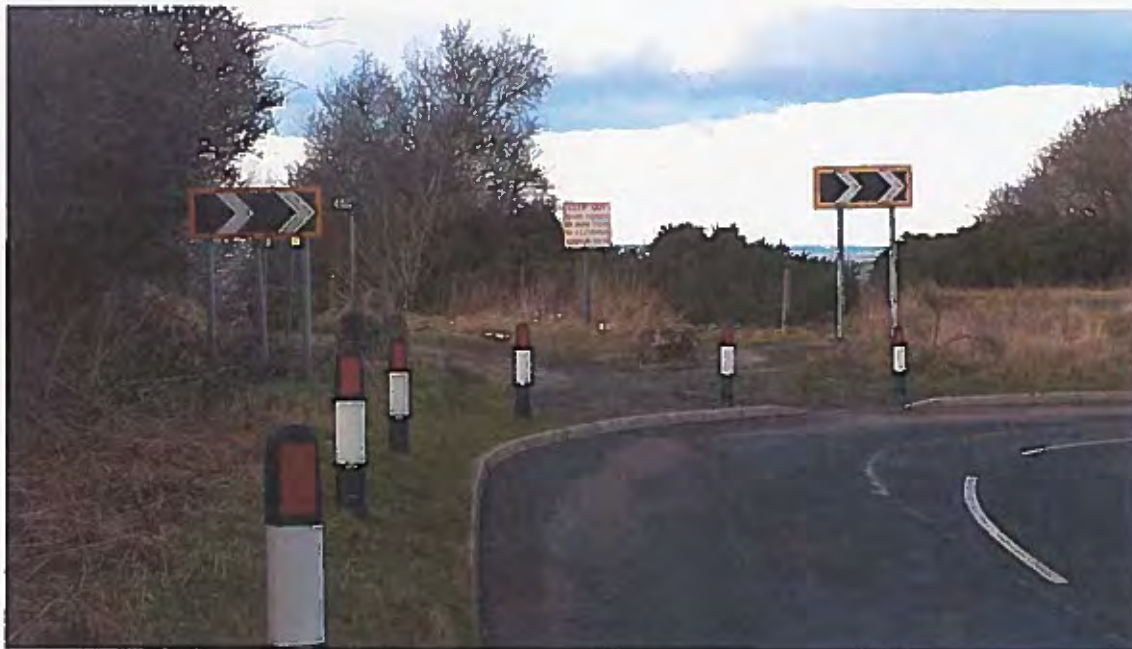
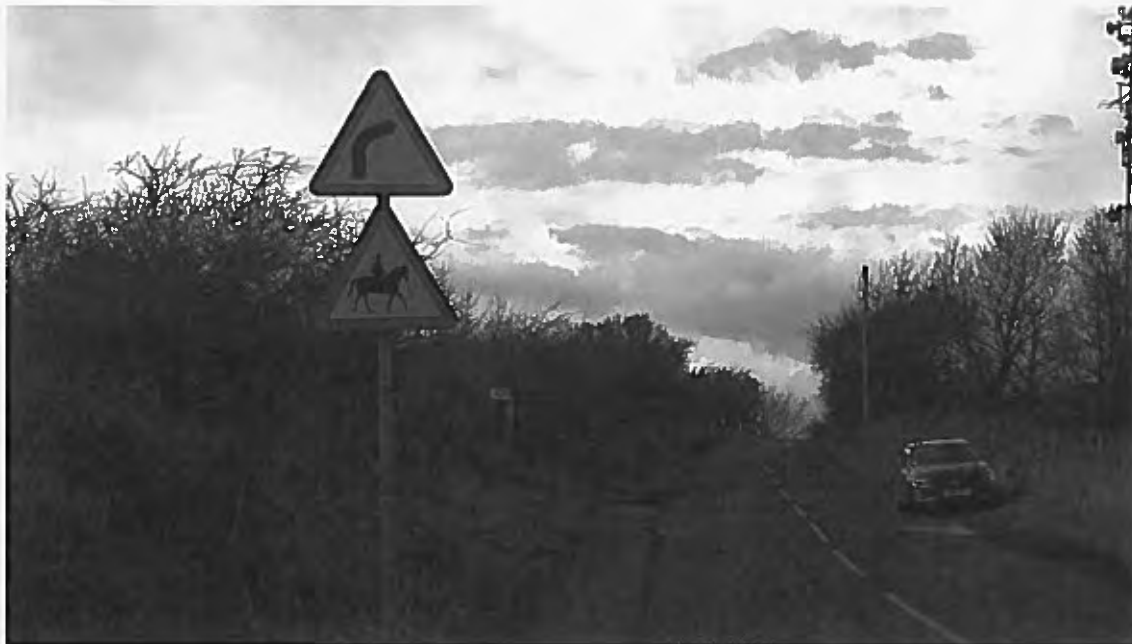
The photographs detailed below that were taken on 28 February 2017 shows the current road signs layout for eastbound traffic following the implementation of the above recommendations/actions.

No.	Recommendation	Action
1.	Provide suitable 'Bend ahead' warning signs in-line with the 85 th percentile speeds on approach to the bend in both directions of travel.	Both 'Bend Ahead' warning signs have been increased in size from 600mm high to 750mm high.
2.	The existing chevron plate for w/bound motorists has slipped down the post and is now not clearly visible	The chevron sign has been re-erected and is clearly visible.

3.	The appropriately sized chevrons (including appropriate yellow backing) should be provided on the bend to benefit both directions of travel. Clear visibility of the signs should be provided.	The size of the yellow boarder on the chevron signs confirms to TSRGD 1994. The chevron sign is still functional and therefore no requirement to make changes until the chevron needs to be replaced.
4.	Due to the amount of kerb strikes, this bend may benefit from additional engineering measures to warn of the bend and reduce approach speeds in both directions of travel.	An additional chevron sign (TSRGD Diagram 515) has been erected for eastbound traffic, offset to the right of the dropped kerbs/track. Hazard Marker Posts (10 no.) have been installed around the outer radius of the bend at 5 metre spacing.

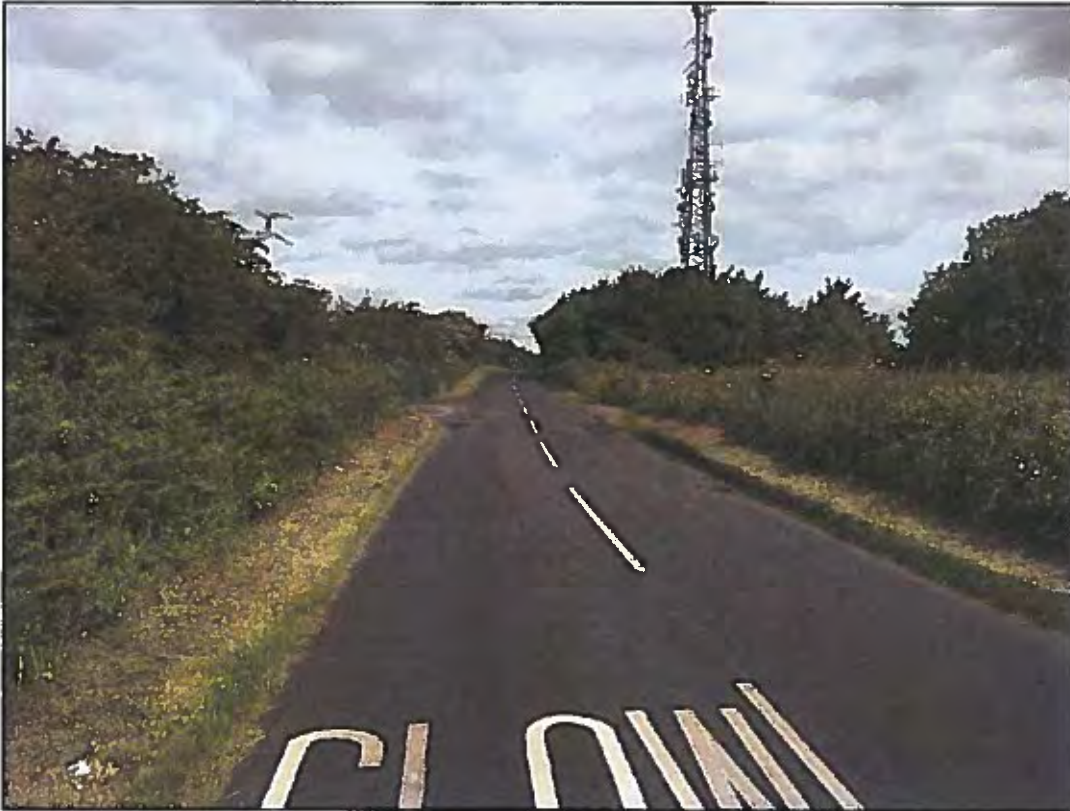
**Photograph approaching the accident location -
Northbound (Direction of travel of Vehicle 1)**

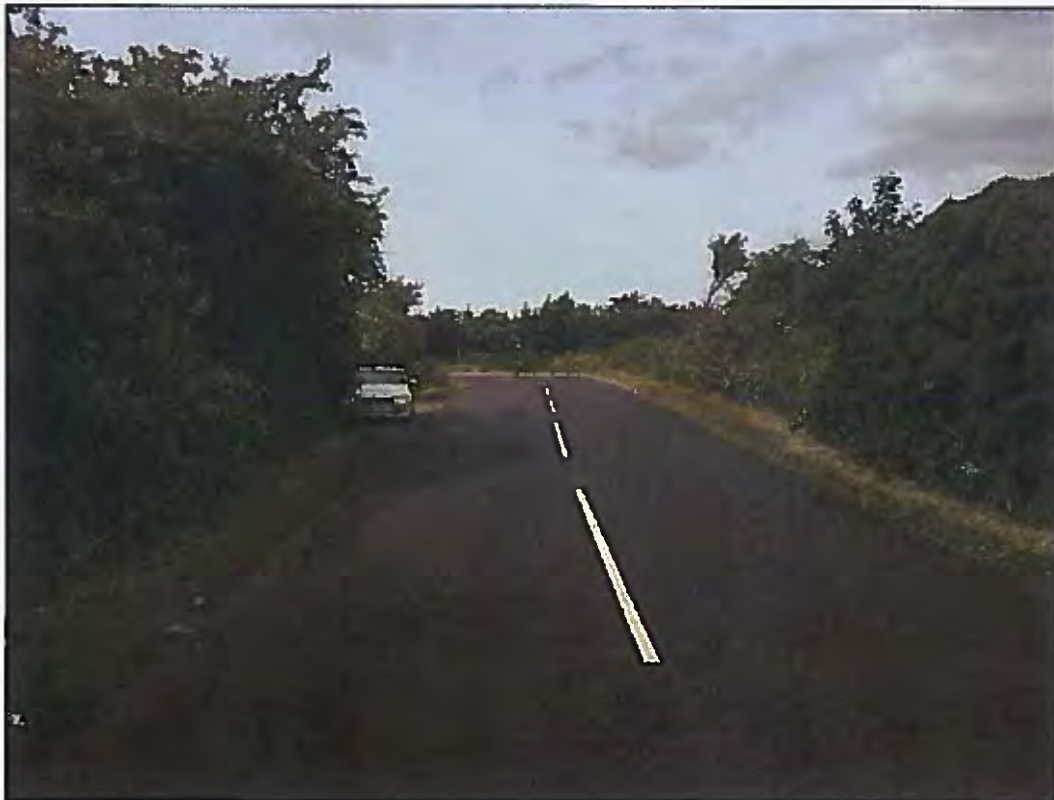
**Photograph approaching the accident location
in the opposite direction - Westbound**

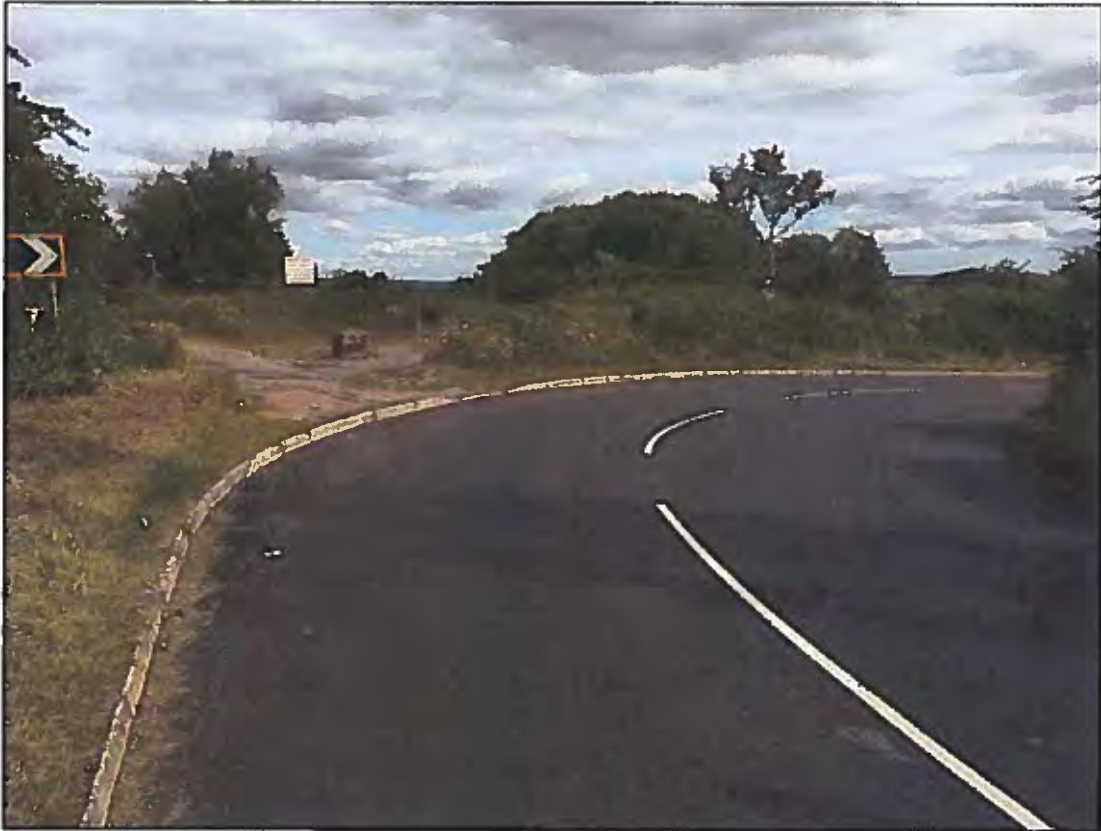
Photograph showing the immediate approach to the accident location - looking north

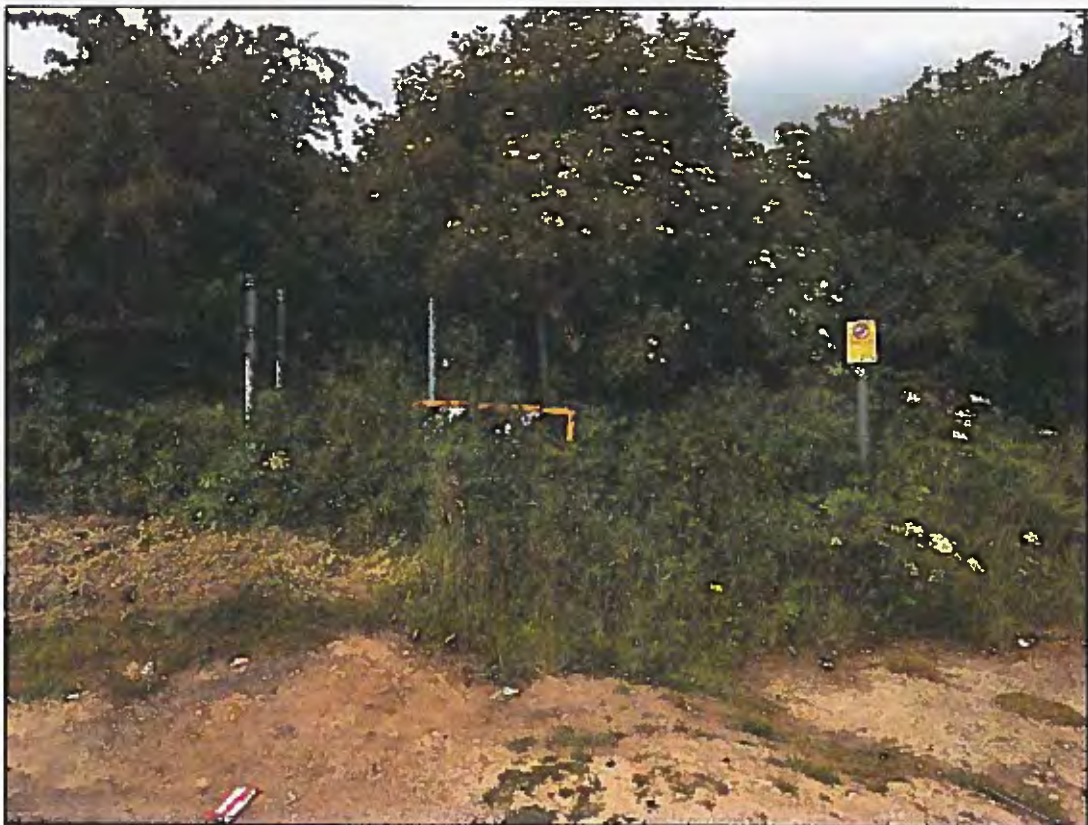
Photograph showing Chevron plate that has slipped down posts - looking west

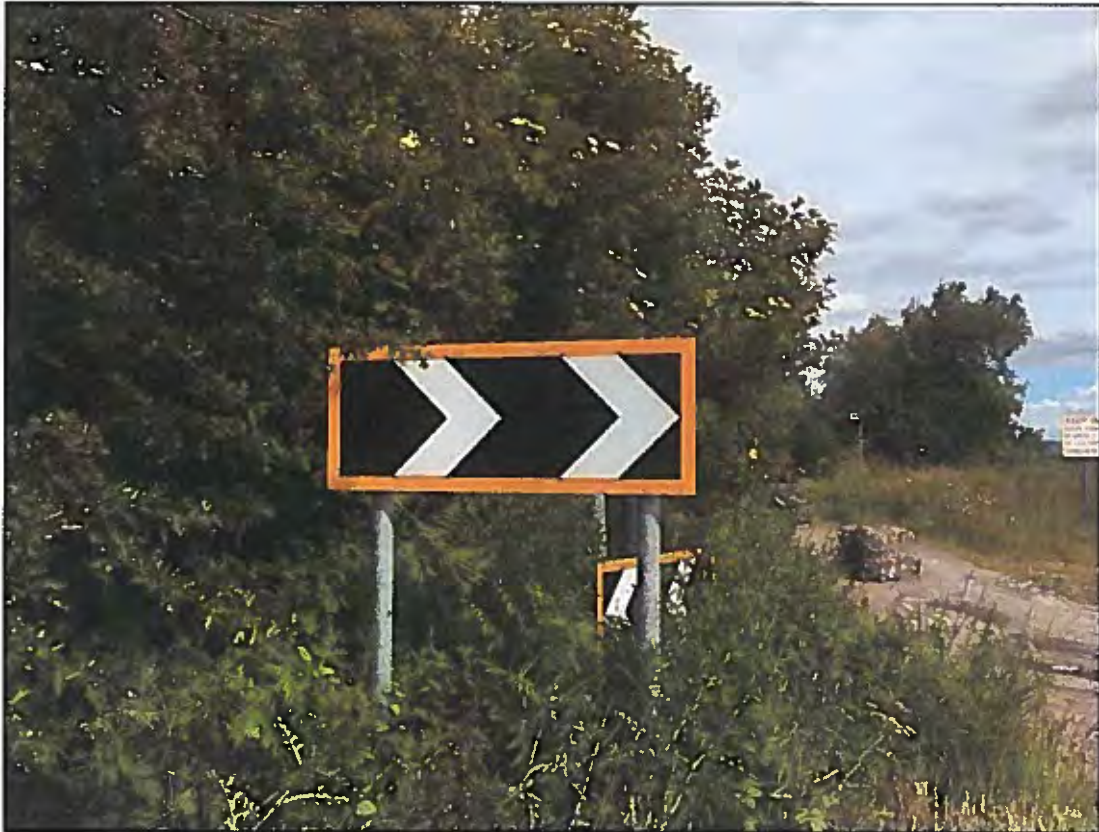
Both Chevron plates are in reasonable condition, however, the yellow backing surround appears narrow in comparison to the size of the signs.

very narrow in relation to the sign size – see photographs at the end of the report. Chapter 7 'The Design of Traffic Signs' states that:

"14.19 In the case of the chevron sign shown in diagram 515, the width of the yellow area should not be less than half the horizontal width of the white chevron."

Photograph showing narrow yellow backing board to Chevron plate - looking north

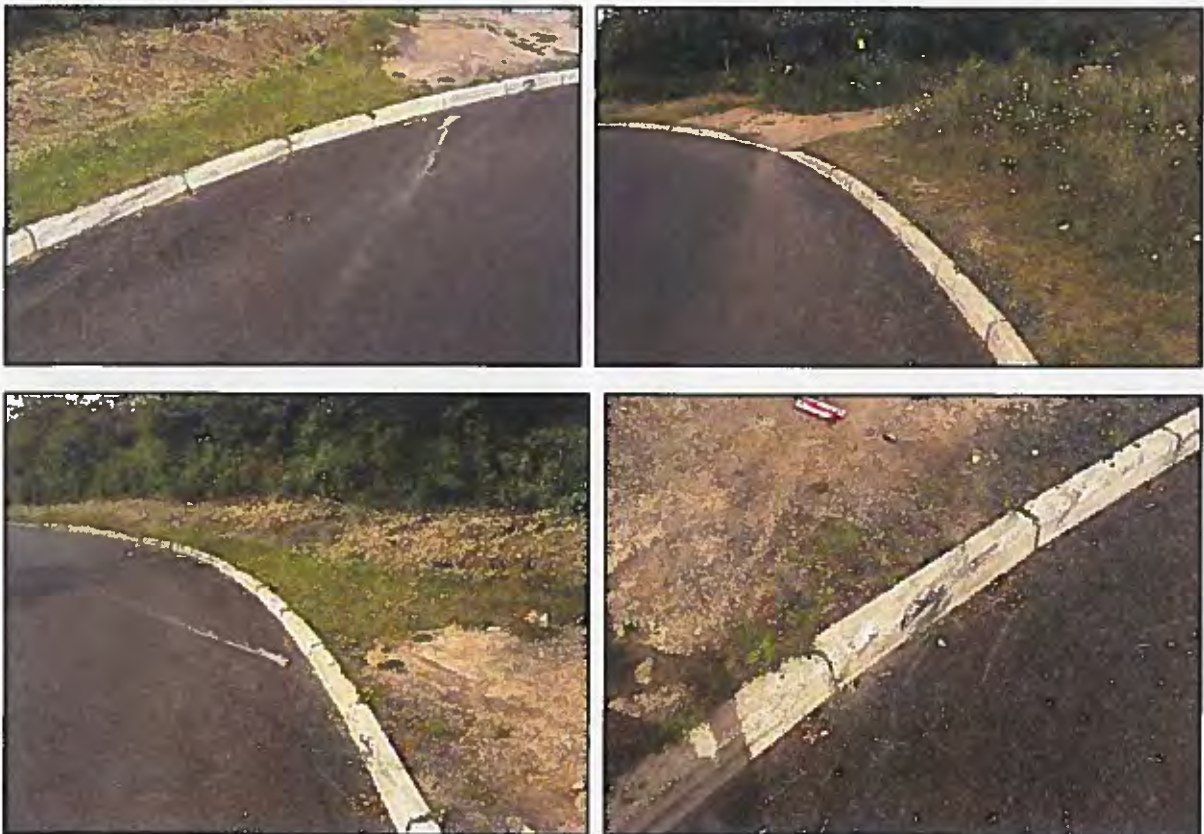
- The kerblines that delineate the outside of the right hand bend displays evidence of several 'kerb strikes' which suggests that this accident is not an isolated event – see photographs at the end of the report.

Photographs showing numerous kerb strikes

- Provide suitable 'Bend ahead' warning signs in-line with the 85th percentile speeds on approach to the bend in both directions of travel.
- The appropriately sized chevrons (including appropriate yellow backing) should be provided on the bend to benefit both directions of travel. Clear visibility of the signs should be provided.
- Due to the amount of kerb strikes, this bend may benefit from additional engineering measures to warn of the bend and reduce approach speeds in both directions of travel.
