Re: Response to Senior Coroners Report – Lynne Pamela Lawrence 17th May 2021

I write in response to a Regulation 28 report provided by Caroline Saunders – Senior Coroner for the area of Gwent following an investigation that was opened on the 13th October 2020 into the death of Lynne Pamela Lawrence.

During the course of the inquest, evidence revealed matters giving rise to concern in relation to the footway condition outside Alma Street, Brynmawr and although the Coroner could not conclude the unevenness of the pavement caused the fall it is considered to be a factor which could put people's lives at risk.

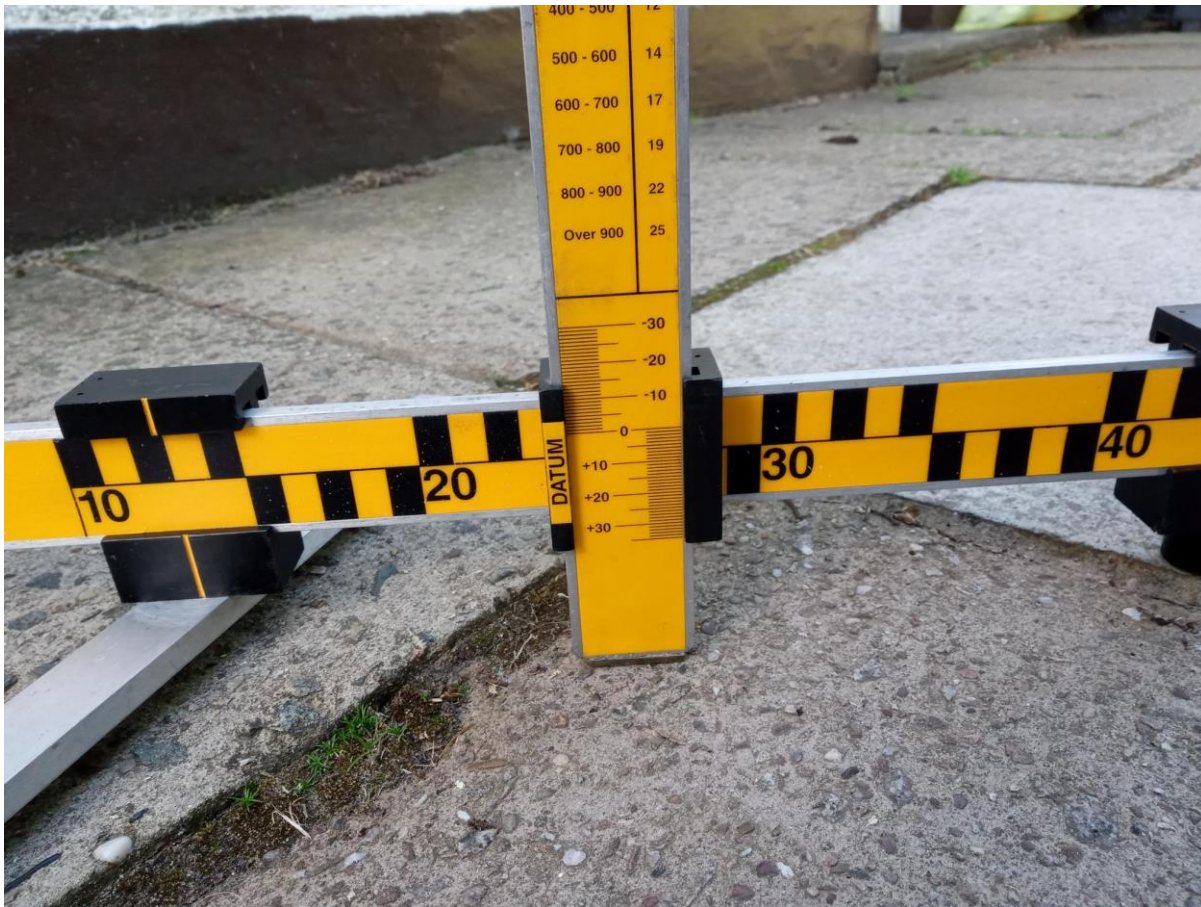
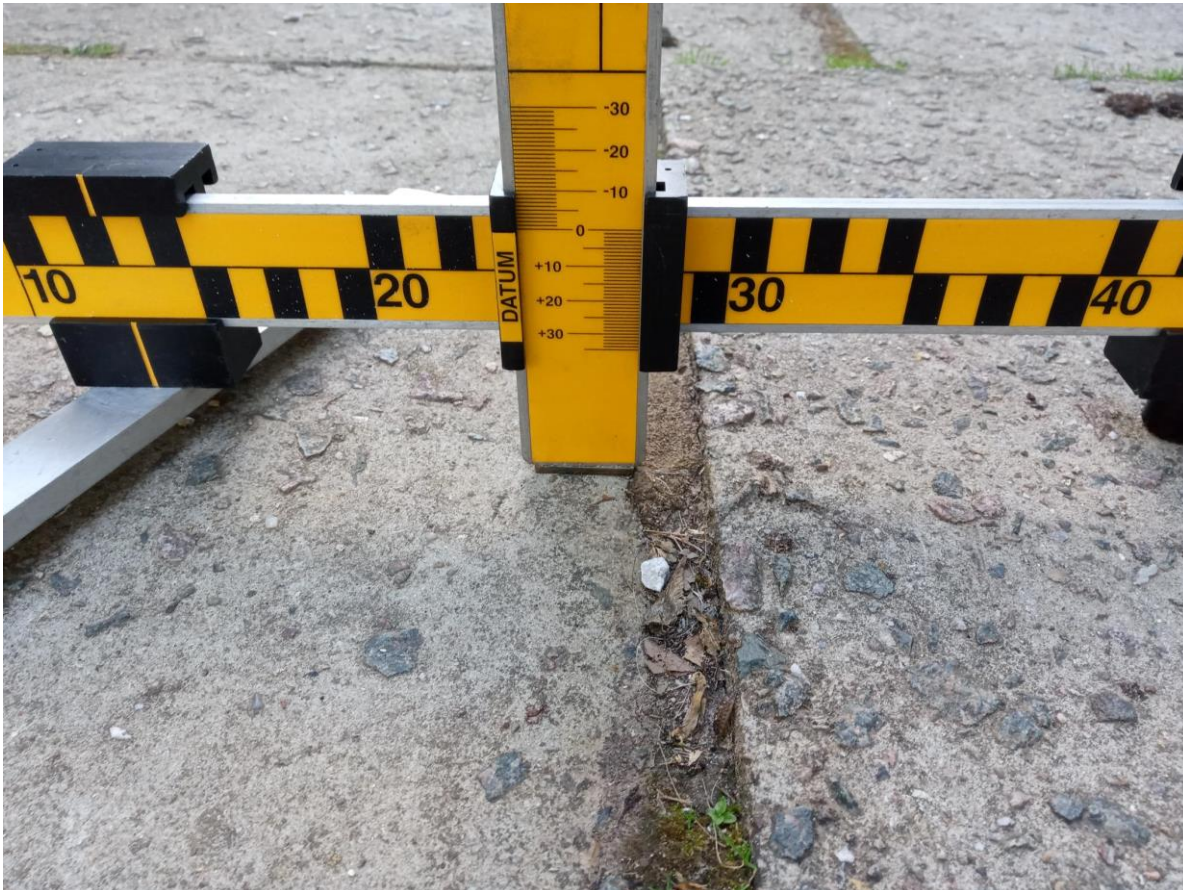
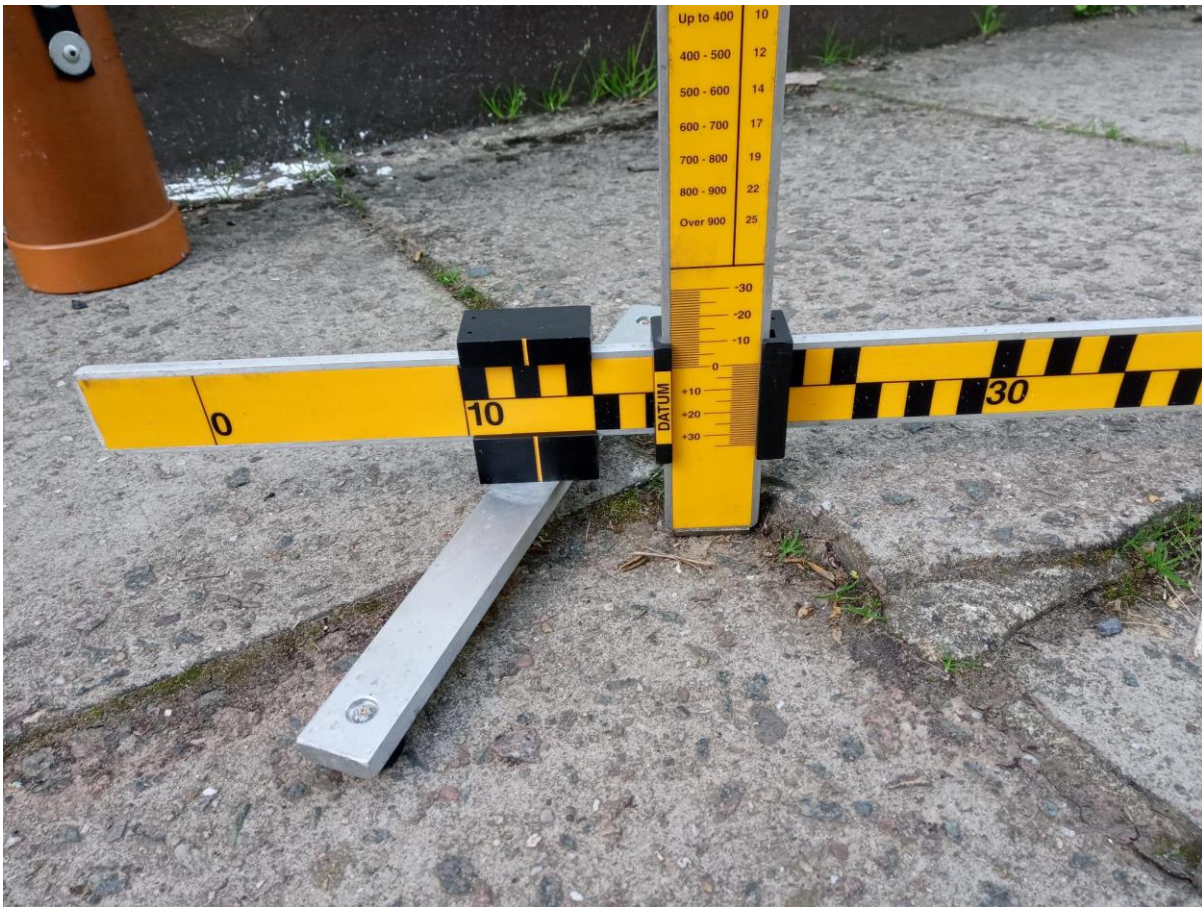
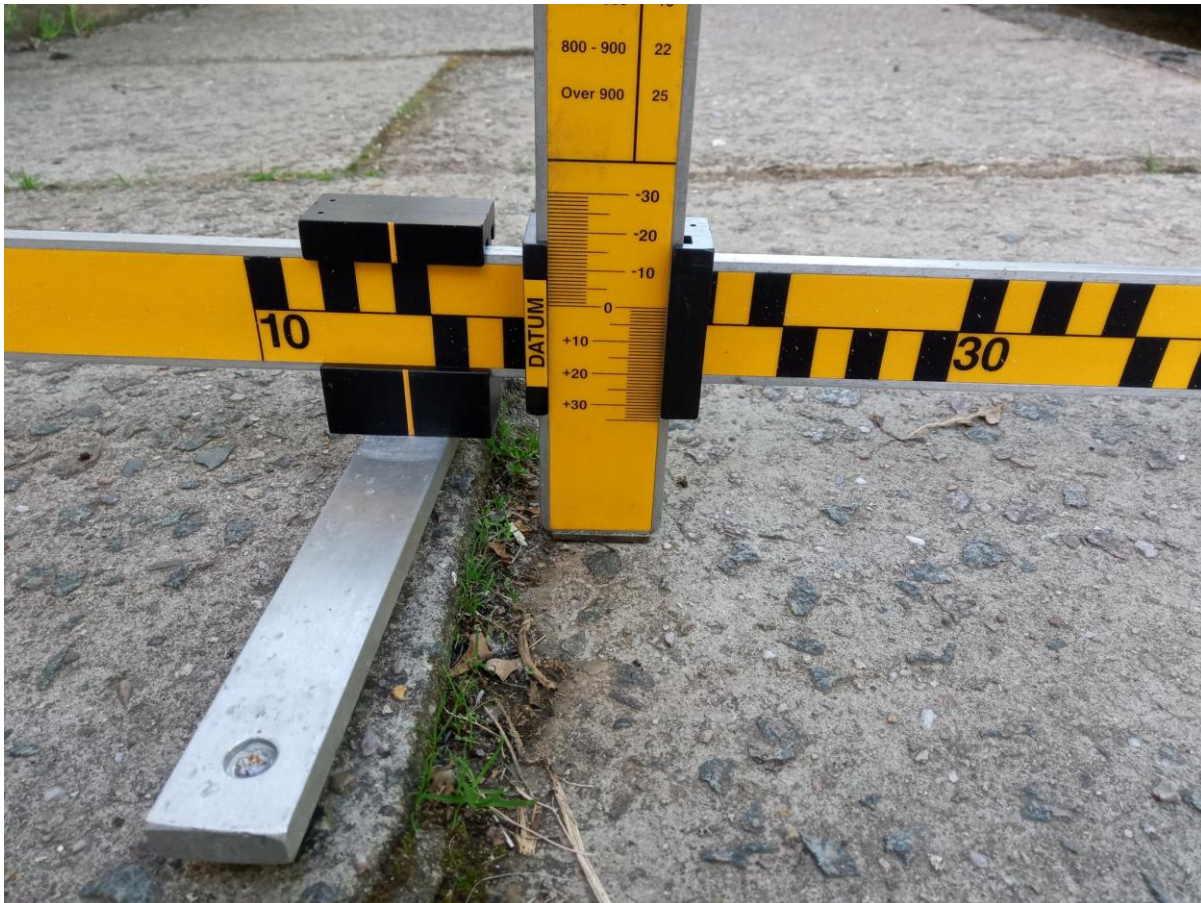
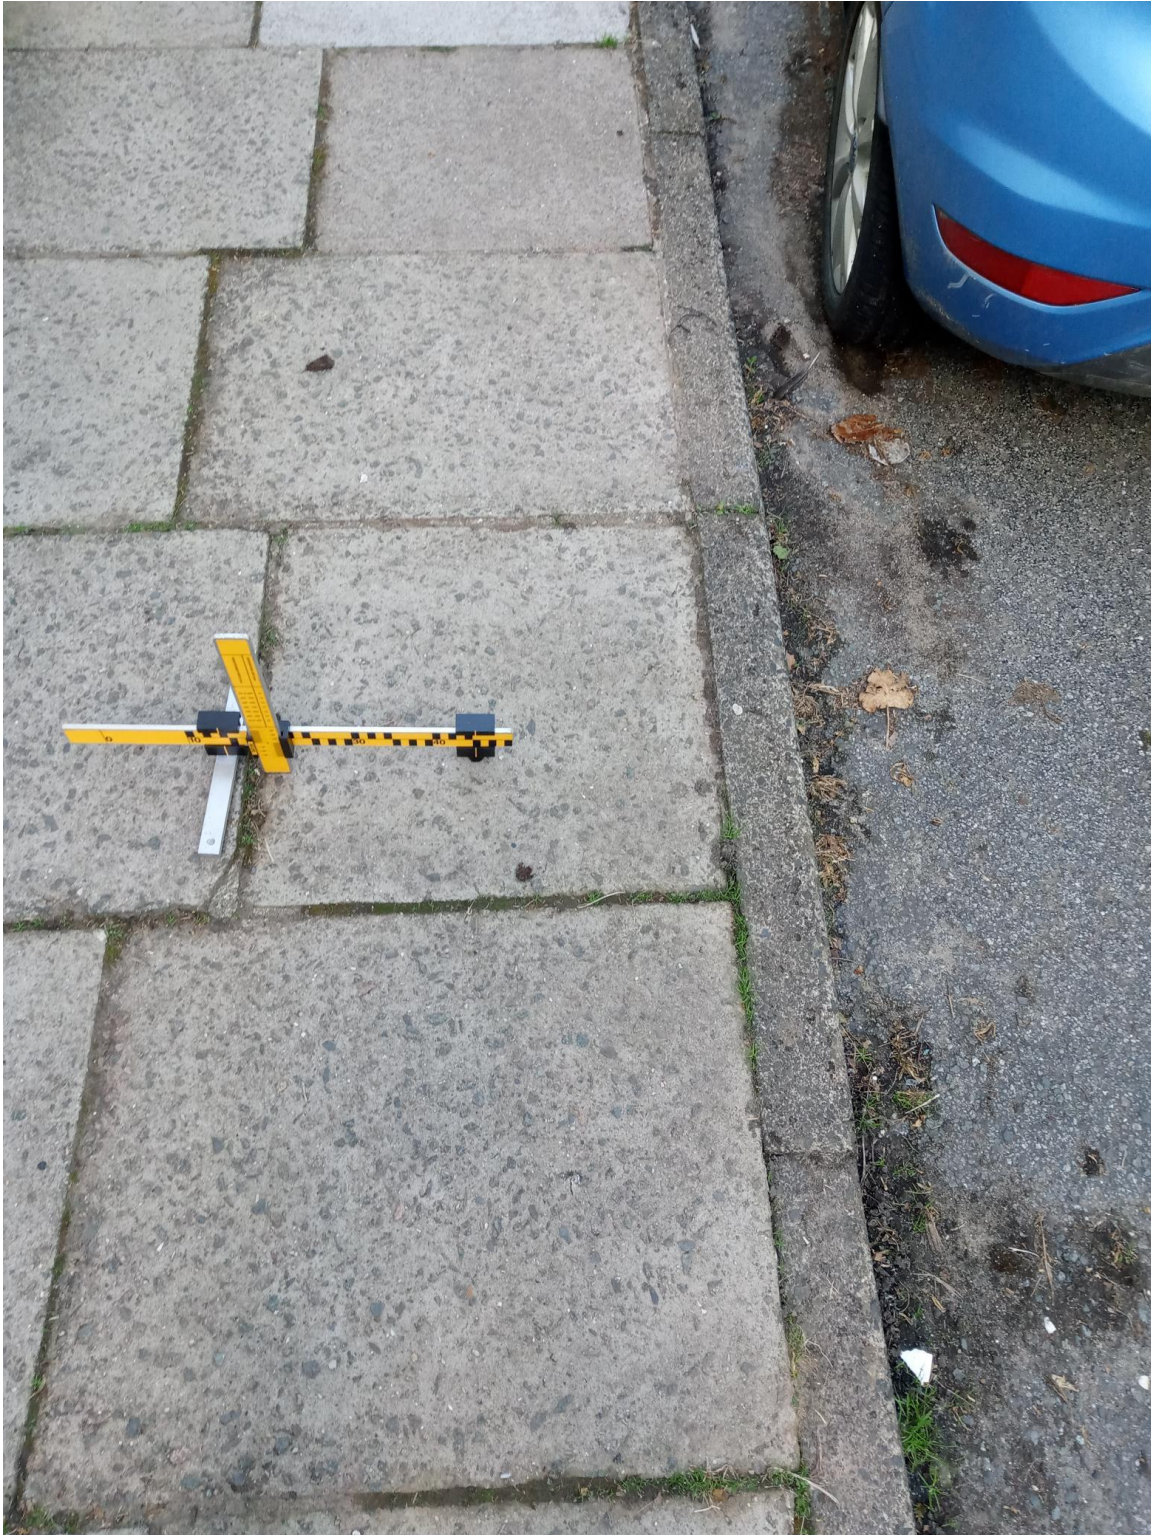
Photo's taken immediately outside number [REDACTED] Alma Stree Brynmawr 4th June 2021

Highway Inspections prior to the accident in July 2020 and post accident in January 2021 have not identified defects approaching this standard >25mm. A further assessment on receipt of the Regulation 28 report has been undertaken and although the footway reconstruction has raised paving <16mm (photo's attached) they are not at a standard that the Highway Authority would intervene or consider a risk to the highway user and as such there are no proposals for BGCBC Highway Authority to take remedial works actions at this location.
