Re Regulation 28 Notice, Mr. Kenneth Audsley

Managing Director Hirst Electrical PHS (UK) Ltd.

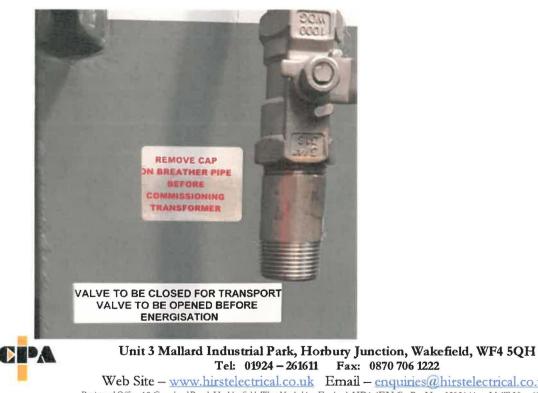
Lastly a sticker has been placed near to the breather line again, giving simple instruction to the end user.
