London Borough of Havering
Highways

Date: 26th October 2020

Please find below our response to the Regulation 28 (Preventing Future Deaths) report sent to us on 4th September 2020, reference [REDACTED].

The incident location within the Regulation 28 (Preventing Future Deaths) report is on Colchester Road, classified as the A12, approximately 65 metres north east of the Gallows Corner roundabout.

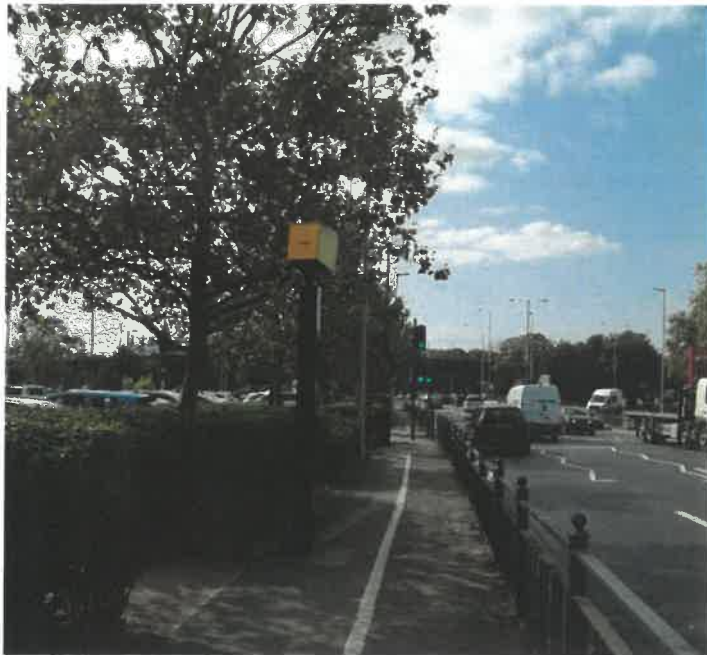
The footway at this location is split into a cycle way at the rear of the footway with the pedestrian side adjacent to the carriageway. The safety camera is located at the rear the footway approximately 25 metres before the crossing, within the cycle way section, and would not cause any sight line issues for car drivers approaching the controlled crossing point.

Safety camera located at the rear of the footway.

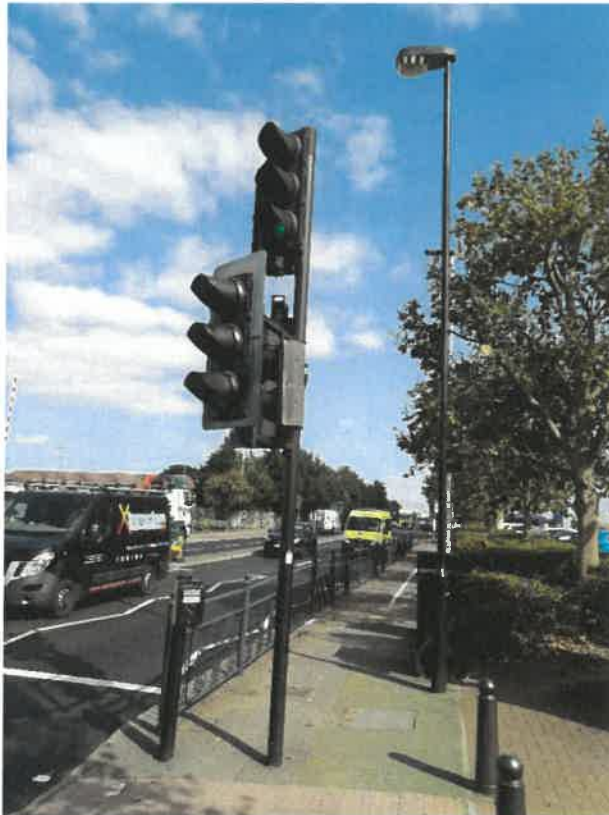
Upon inspection on the 17th September 2020 all the trees that are contained within the grounds of the Gallows Corner Retail Park were found to be well cut back, with no branches lower than six foot overhanging the footway. There were no branches overhanging the carriageway at all. At the crossing point itself there is a street light that illuminates the crossing point at night, and this area was found to be completely clear of any over hanging branches so there would be no shadows over pedestrians waiting to cross at this point on the footway.

Unobstructed lamp column at the controlled crossing point.

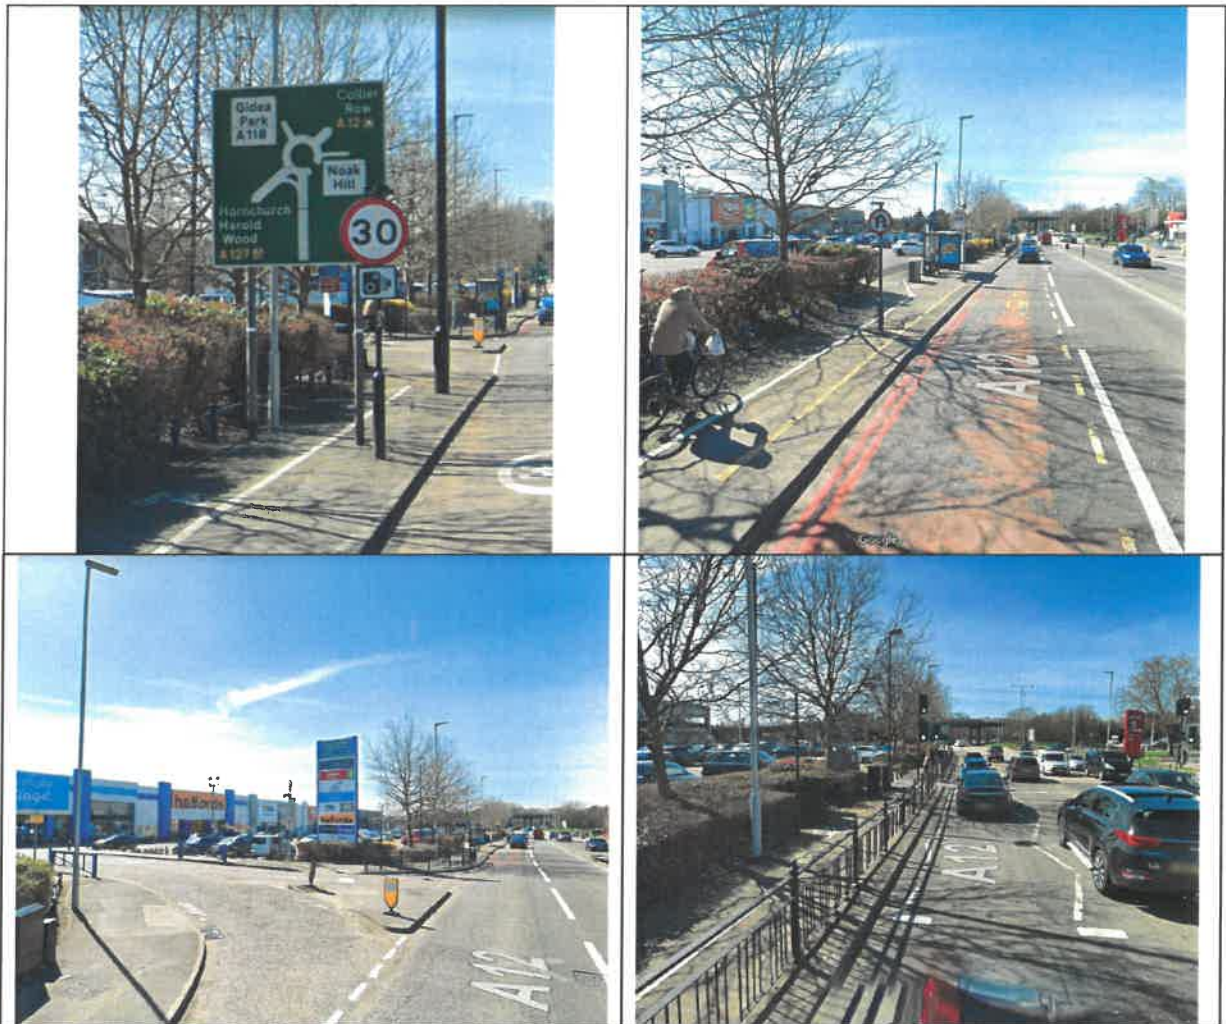
With regard to signage, there is no signage blocking sight lines at the crossing point, and there is very little signage on the approach to the controlled crossing either (see photos below). The large roundabout sign is some 140m prior to the crossing point, and the only other road sign is a "no u turn" sign approximately 70m before the crossing, neither of which would obstruct drivers' sight lines.

Signage in the vicinity of the controlled crossing point

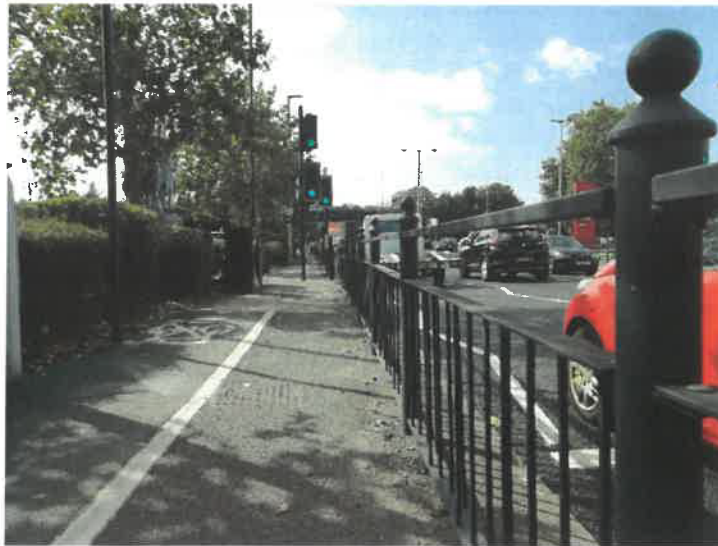
Although not mentioned in the report, but worthy of note, is the fact that there is pedestrian guard railing along the length of the footway for approximately 30m prior to the controlled crossing. As can be seen from the photo below there is a clear viewing panel through the guard railing to aid drivers to see whatever is on the footway or waiting at the crossing point.
