**INQUESTS INTO THE DEATHS OF YVES MARIE GLOAGUEN AND PASCAL LE  
FLOCH ARISING FROM THE LOSS OF THE VESSEL BUGALED BREIZH ON 15  
JANUARY 2004**

**SUMMING UP AND FINDINGS OF JUDGE LICKLEY QC**

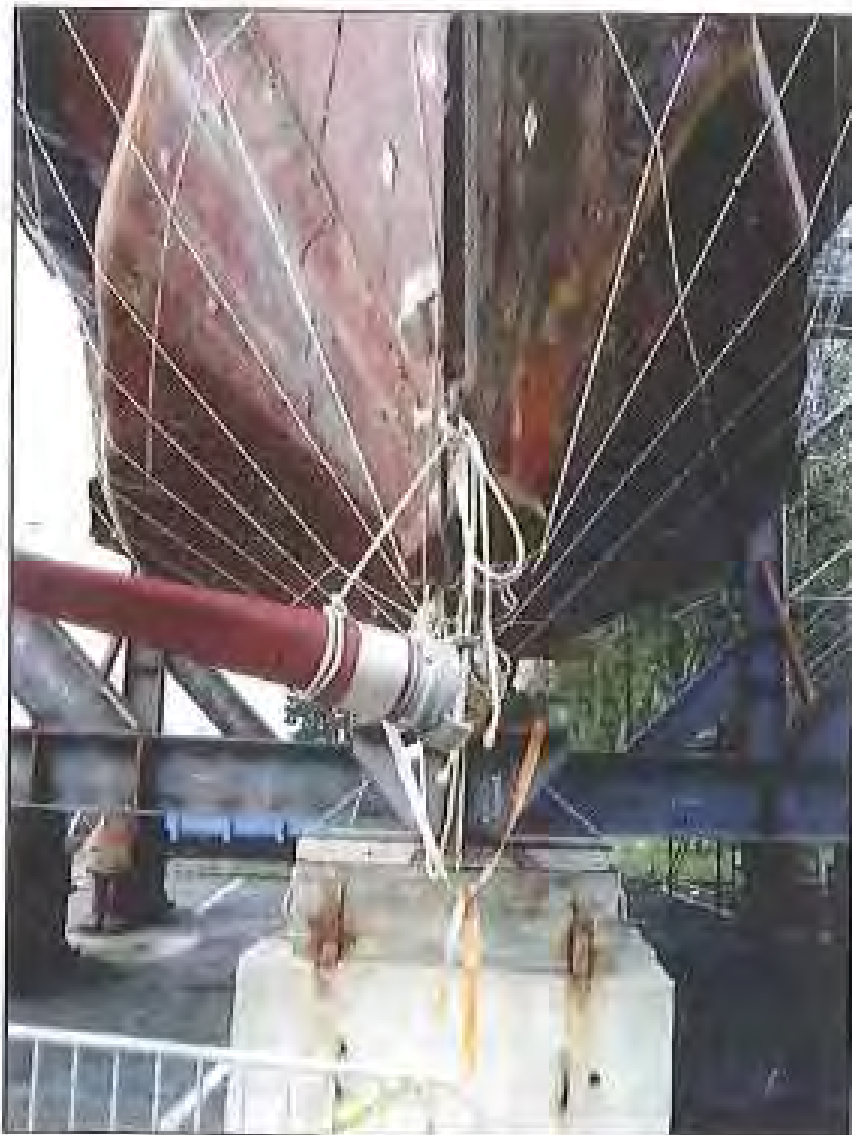
View of the deformation of the starboard side. The photograph shows the deformation in way of the fish hold and the double bottom below it. The bowing of the keel can also be seen.
