London Borough of Havering
Highways

Date: 26th October 2020

Please find below our response to the Regulation 28 (Preventing Future Deaths) report sent to us on 4th September 2020, reference [REDACTED].

The incident location within the Regulation 28 (Preventing Future Deaths) report is on Colchester Road, classified as the A12, approximately 65 metres north east of the Gallows Corner roundabout.

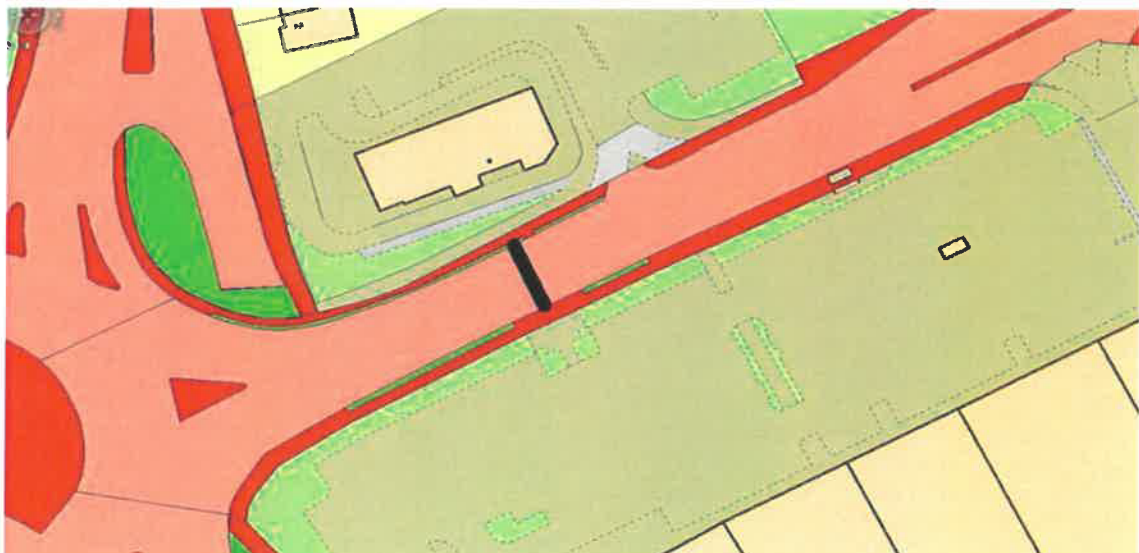
The extract below taken from Havering Councils Highways Register overlay on Earthlight shows that this location in black, along with the boundary of the adopted highway (red is footway, pink is carriageway).

Boundary of the adopted highway taken from Haverings Hghways Register on Earthlight

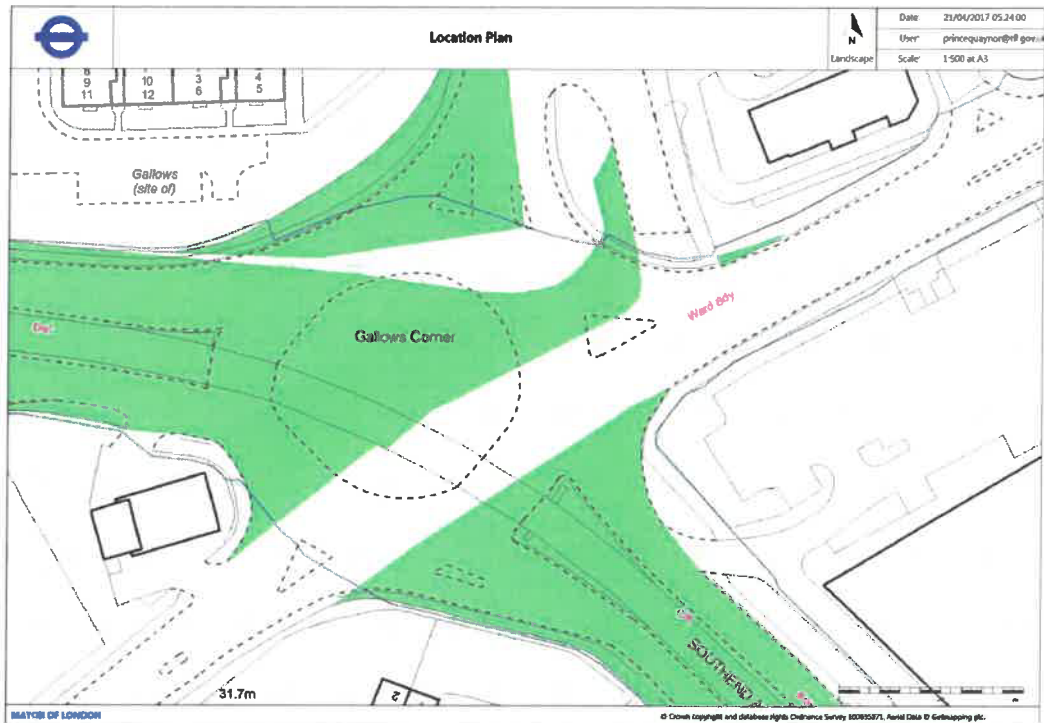
TfL supplied boundary plan.

The TfL an shows a dotted line as the kerb line along the edge of the footway, while the solid blue line that runs almost parallel to this line at the rear of the footway shows the limits of TfLs responsibility as the Highway Authority.
