## **REGULATION 28 REPORT TO PREVENT FUTURE DEATHS**

## 1 HIGHWAYS ENGLAND

## **3 DETAILS OF ACTION TAKEN**

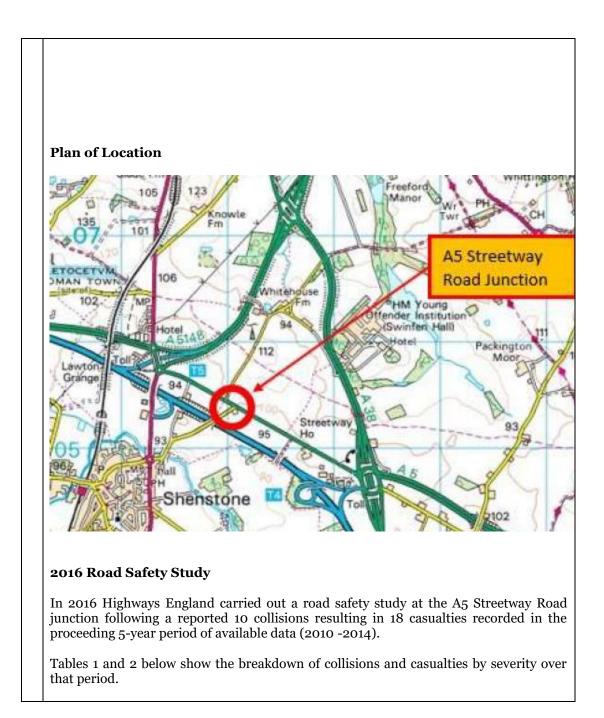
Streetway Road is an unclassified rural road that links the A5127 to the A5. It is used locally as a rat run for cut-through driving to avoid the roundabouts at Wall. It varies in width from approx. 4.6 metres to 5.8 metres with a central warning line installed on part of the road. It joins the A5 at a slight angle and forms a Y shaped junction with a grassed splitter island. Traffic entering and leaving Streetway Road can pass on either side of the grassed splitter as they are marked as two way. Both junctions with the A5 are marked with transverse 'Give Way' markings, 'Give Way' triangle markings, 'Give Way' signs and an advanced 'Give Way' sign. Streetway Road is also subject to a 7.5 tonnes weight restriction.

The A5 between the two roundabouts is a wide two way single carriageway approx. 10 metres wide. The alignment is straight and relatively level with the junction with Streetway Road sitting on a slight crest. The A5 is subject to the national speed limit (60mph for single carriageway) and is not restricted to 50mph as provided in the Coroner's report. Street lighting is not present other than at the roundabouts at either end of the single carriageway section. The carriageway has one metre wide hard strips on both the nearside channels, and central hatching road markings to the centre of the road approx. one metre wide. Yellow backed junction warning signs are provided in both directions approx. 200 metres in advance of the junction.
