DAF Trucks Limited

DAF Trucks Ltd. Reference: 0G034509/CF370FAD/Fatal/ [REDACTED]

Vehicle: XLRADM4100G034509 CF 370 FAD, LN64FYO

I am writing to you in response to the report (KM/ST/16216) issued to DAF Trucks Ltd on 17/09/19, regarding the prevention of future deaths, with respect to the fatal incident involving vehicle 0G034509 CF 370 FAD operated by Whitelock Plant Ltd of Skipton.

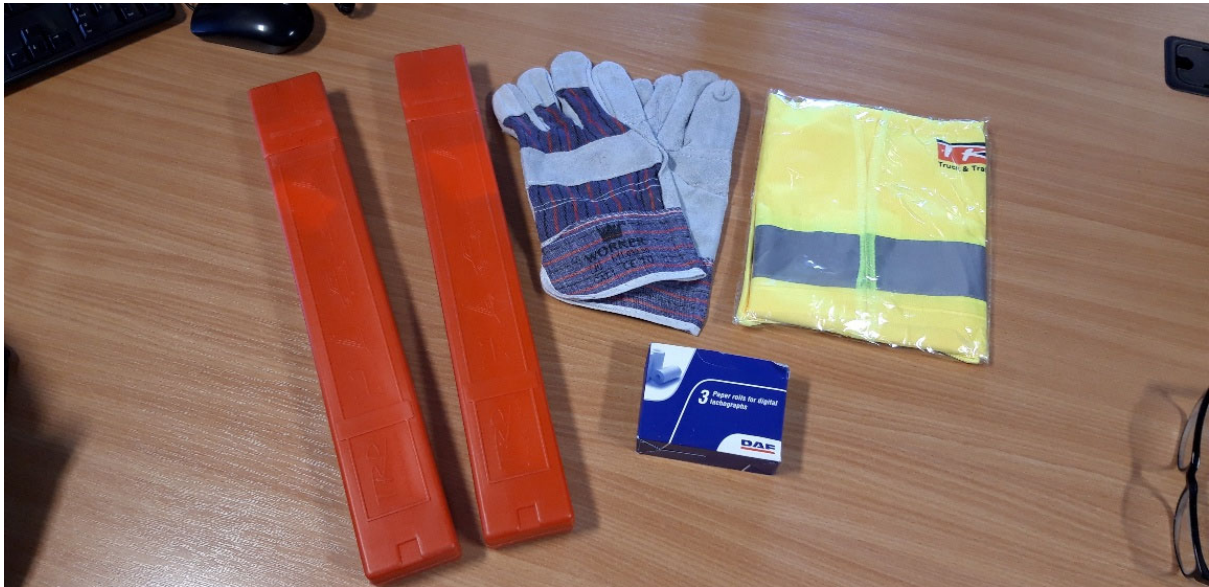
Appendix 1

DAF Trucks Ltd issues to all new vehicles including XLRADM4100G034509 a PDI safety kit. This Bagged kit (DAF part number 9507301) includes x2 Hazard Warning Triangles x3 Tachograph paper roll, x1 Hi- Viz vest and a pair of safety working gloves. A photo of this kit is shown below

- a. DAF Trucks Ltd issues to all new vehicles sold via the sales network a PDI safety kit. This Bagged kit (DAF part number 9507301) includes x2 Hazard Warning Triangles x3 Tachograph paper roll, x1 Hi- Viz vest and a pair of safety working gloves. A photo of this kit is shown in Appendix 1.
